THE MANUFACTURING TECHNIQUE OF NATIONAL TREASURE NO. 141:

BRONZE MIRROR WITH TWIN KNOPS AND FINE GEOMETRIC DESIGN

Park Haksoo, Conservation Scientist, Conservation Science Team, National Museum of Korea

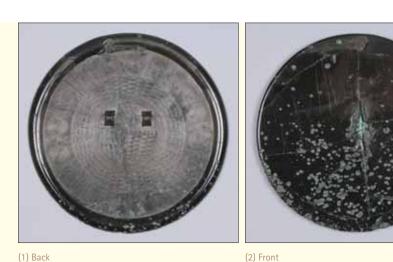
(Figure 1) NT 141, the Bronze Mirror with Twin Knops and Fine Geometric Design after conservation treatment

As seen in Figure 1, NT 141 has a horizontal diameter of 212.1mm and a vertical diameter of 212.8mm. The front of the mirror is flat while the back has two knops and is decorated with a geometric design. The decorations on the back of the mirror can be divided into three ring-shaped zones: inner, middle and outer. The outer zone contains vertical rows of triangles filled with slanting lines, in between which lie four pairs of concentric circles.³ The middle zone was also decorated using triangles filled with slanting lines. Finally, the inner section of the mirror was divided into four panels, each of which was again decorated using triangles filled with slanting lines. The two knops are located slightly above the center point of the mirror and knop core prints can be found on either side of the knop holes. The inner zone of the mirror was found to be relatively thicker than the outer zone, thereby making the mirror convex in form.

The bronze mirror currently consists of 19 fragments, with a missing section extending vertically between the two knops. Missing sections are also located along the upper parts of the rim, to the left and right. The lower part of the outer zone also contains a missing section.

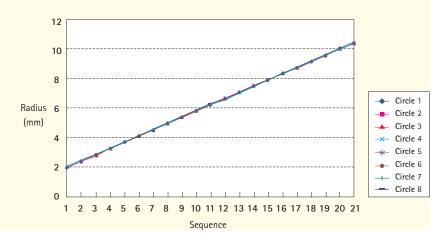
(Figure 8)

The radii of the concentric circles in the outer zone can be obtained by selecting three points on the circumference using an image analyzer – in doing so, a circle can be drawn and its center point established. Through this method, the radii of the 21 circles which comprise each concentric circle (excluding the two to three curved lines in the center) were obtained. Table 2 presents a list of the radius measurements, and Figure 8 presents the distribution of these values. The distribution of the radius values of the 21 circles which form each concentric circle was found to be similar in nature, thereby suggesting that the concentric circles had been drawn at the same time using a multiple-toothed implement. In addition, the circles near the curved lines (which had been drawn by hand) were found to have been slightly modified or contained erased parts, as can be seen in Figure 9. One possible explanation for this is that in drawing the circles with a compass, the holes left by the compass

Distribution of radius values from the concentric circles of the mirror's outer zone

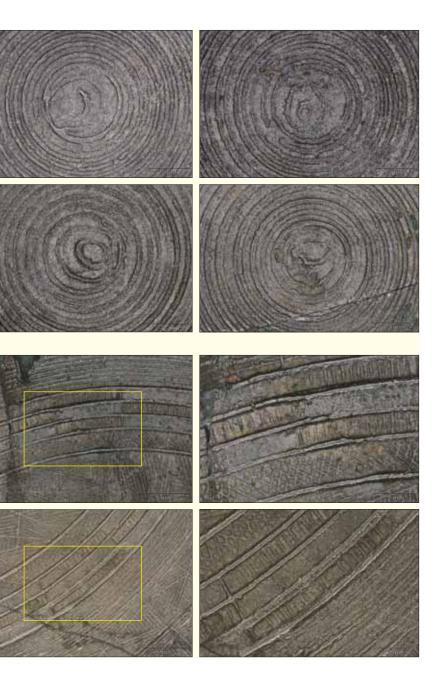
(Figure 10) Circles located just outside the inner zone of the mirror

Figure 10 presents the circles located just outside the inner zone of the mirror. The points where the starting and end point of each drawn circle met can be observed near the top of the circles, but interestingly enough, these meeting points do not form a straight line from the Center Point O (Figure 10-1, 10-2). This would not be the case if the circles had been drawn simultaneously using a multiple-toothed implement. In addition, the meeting point of a circle can also be observed to the lower right hand side of the inner zone (Figure 10-3, 10-4). Therefore, it should be assumed that the circles located just outside of

Top left: (1) Area above the inner zone

Top right: (2) Close-up of (1)

Bottom left: (3) Area below the inner zone

Bottom right: (4) Close-up of (3) spike were later filled in using moulding sand, some of which became trapped in the incised circles, therefore, these zones had to be re-drawn by hand later. The possibility that the compass spike hole would have been erased by infilling it with earth or sand has previously been suggested by others as well.¹⁰

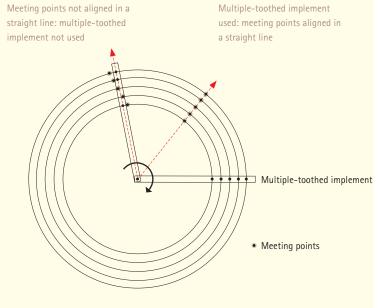
(Figure 11)

Schematic drawing of circle meeting points and actual meeting points of circles located outside the inner zone of the mirror

The meeting points of circles and straight line drawn from Center Point O

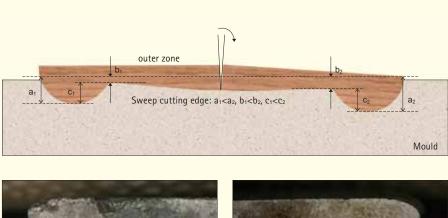
(Figure 13)

Diagrammatic cross-section showing possible use of a sweep cutting edge

(1) Changes in cross-section thickness when a sweep cutting edge is used

(2) Cross-sections of the outer zone and rim (left and right)

not even. If a stamp mould had been used, as illustrated in Figure 13, and if that stamp mould had been pressed unevenly, leading to differences in the thickness in the left and right parts of the rim $(a_1 < a_2)$, the right side of the outer zone should be thicker than its left side $(b_1 < b_2)$, and the difference in thickness between the outer zone and the rim should also be greater on the right than on the left $(c_1 < c_2)$, as schematically demonstrated. However if we look at Figure 13-2 which shows the left and right cross-sections of NT 141 upside-down, it is possible to confirm that the thickness of the left outer zone is greater than that of the right $(b_1 > b_2)$. Therefore, it appears that in forming the rim, a sweeping cutting edge was not used. The fact that the center point of the inner circle of the rim (i.e. its boundary with the outer zone) coincides with the center points of the other circles, makes it also unlikely that the rim was carved out using a pre-existing pattern. In other words, it appears that the rim was first drawn onto the mould and then carved out. As for the other areas of the mirror back, it is difficult to know how the designs were made. However, the use of a sweep cutting edge would have made it easier to establish the center point, thereby facilitating the drawing of circles which were later added on. It is therefore likely that a sweep cutting edge was used which did not include the shape of the rim.

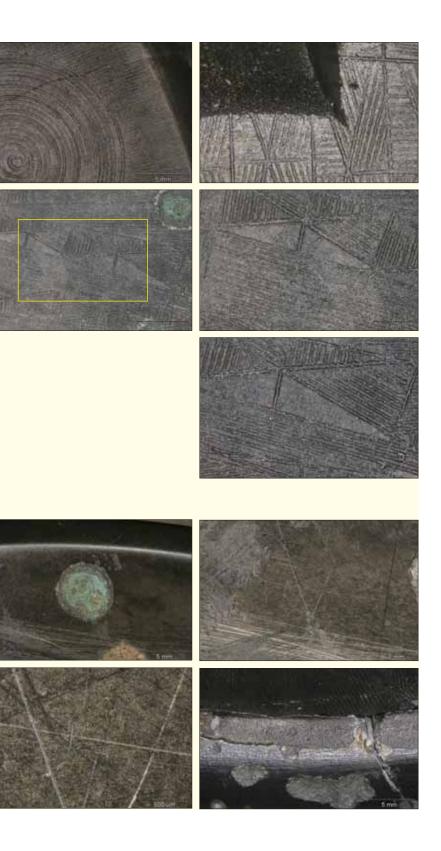
However, in the case of NT 141 (Figure 14), the decorative lines of the outer zone located near the boundary where it meets the rim do not demonstrate any differences in height, as can be seen in Figure 14-1. Therefore, in the case of NT 141, it appears that the rim was carved subsequent to the decorations of the outer zone. In addition, if we continue to adopt the above reasoning, it can be said that the knops were carved after the decorations of the inner zone, since none of the patterns of the inner zone extend to the knop (Figure 14-2).

Finally, it can be observed that some of the triangles located in the lower right side of the outer zone were not in-filled with slanting lines (Figure 14-3~14-5). This illustrates that the slanting lines were added after the triangle motifs were drawn, but it is unclear why these patterns were left unfinished.

(Figure 14) Line decorations which demonstrate carving sequence

(Figure 15) Polished state of each section

Bottom right: (4) Detail of the rim polished. The rim was not as finely polished as the front of the mirror, and its boundary with the outer zone was not polished at all. It is likely that this was in order to prevent the designs of the outer section from being erased during polishing. The fact that Defect 4 remained on the rim, as well as the fact that traces of rat-tail defects are still present, indicates that the polishing was not heavily carried out.

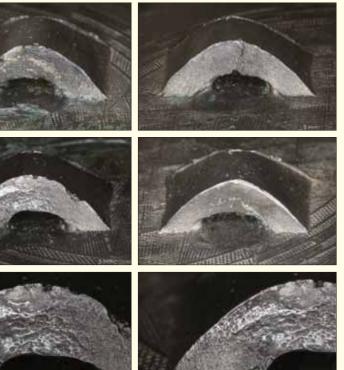
(Figure 16) Traces of wear on the knops

Whether or not the mirror had been used was determined by inspecting the degree of roughness of the edges of the knops. If the mirror had been hung using a cord fastened to the knop, the friction caused by the cord would be expected to result in differing degrees of surface roughness, compared to the parts of the knop which were not rubbed by the cord. Figure 16 presents the inward-facing and outward facing surfaces of the knops; the latter were found to demonstrate similar degrees of roughness to those on the inwardfacing sides. On the other hand, the outward facing surfaces of both knops were found to be smooth from the center to the upper part of the knops, unlike the edge surface which was rough. This smooth surface

would not have been possible when the knop sections were originally cast, and therefore can be regarded as being the result of wear due to friction. The fact that such a smooth surface exists only on the upper surfaces of the knops indicates that the mirror was hung using a single cord inserted through the holes of both knops. The mirror would have hung at an angle, as is suggested by the nature of the wear. Observation of the knop hole from the side confirmed that it was oval in shape, as illustrated in Figure 17. The space between the knop hole and the edge of the knop was found to go in slightly, and this area was separated from the edge of the knop by an arc-shaped line (Figure 16). This shows that the core print section on the mould, where the core print of the core was located, was made by carving an arc-shaped space (in cross-section) and installing an oval core. The

Left: (1) Inward-facing side of the left knop Right: (2) Inward-facing side of the right knop

Left: (3) Outward-facing side of the left knop Right: (4) Outward-facing side of the right knop

Left: (5) Area of wear on the outward-facing side of the left knop Right: (6) Area of wear on the outward-facing side of the right knop

Left: (7) Area of wear on the outward-facing side of the left knop Right: (8) Area of wear on the outward-facing side of the right knop

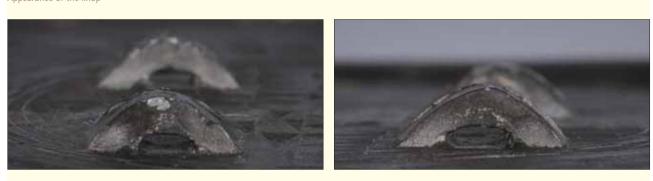
(Figure 17) Appearance of the knop

(1) Knop hole of the left knop

gap between this arc-shaped space and the core print was found to have been packed with infill material, and it appears that this infill was slightly pushed out. On the other hand, observation of the knop from above shows that the area where the core print was originally placed was pushed out slightly (Figure 5-1 \sim 5-3). It is assumed that the evaporation of moisture caused the infill to shrink and its area was pushed out after casting.

(2) Knop hole of the right knop
